Expanding Conservation/Sediment Control Practices in Priority Farm Areas of the Guánica Bay Watershed

***Final Comprehensive Report
November 29, 2016***

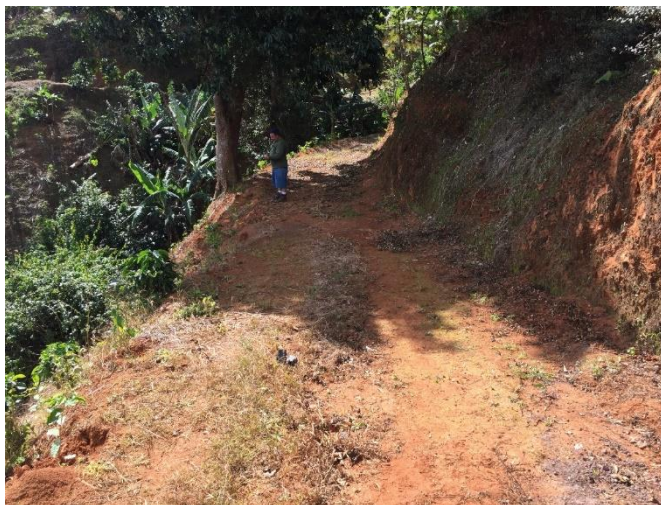
Figure 4. Photo showing the conditions of the dirt roads within San Carlos Farm during assessment visit.

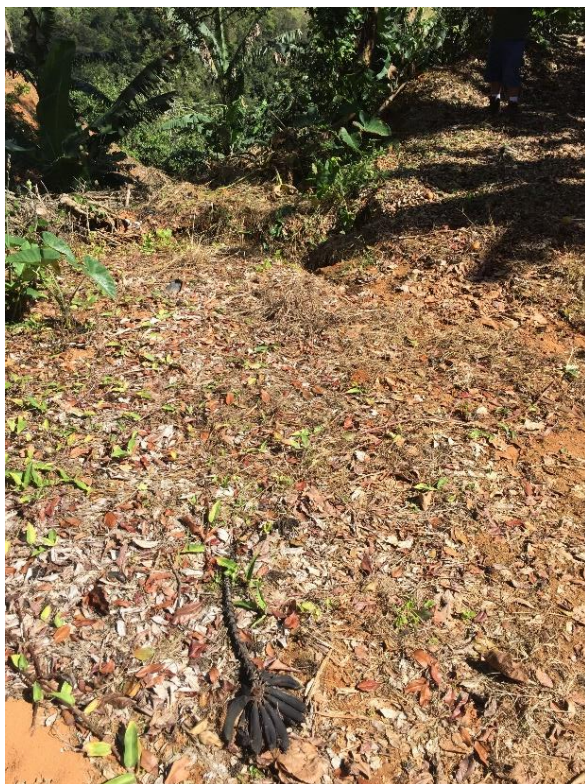
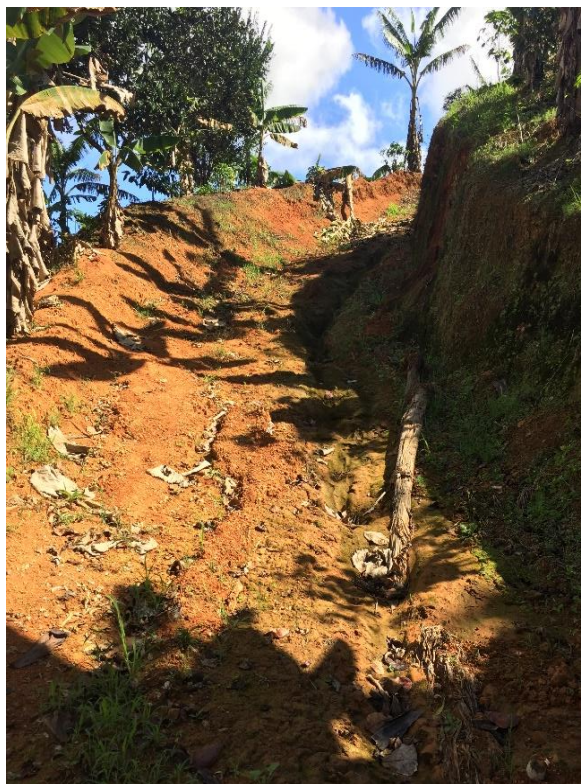
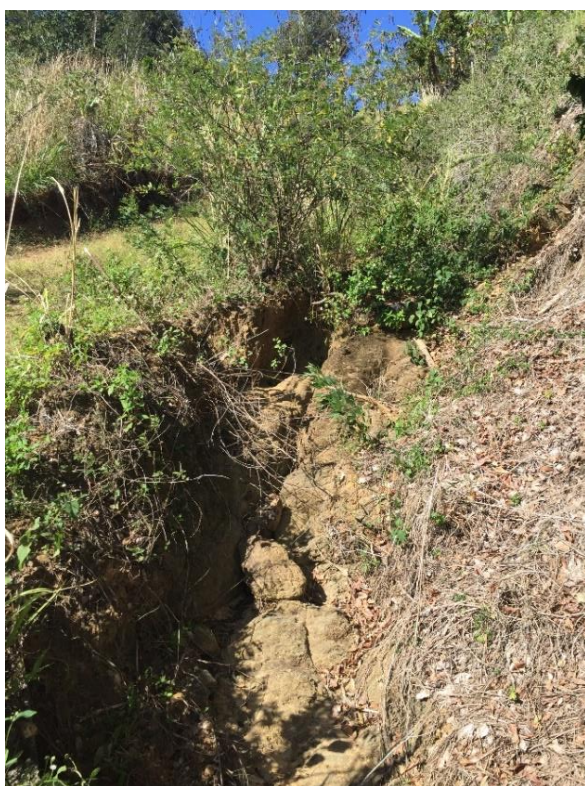
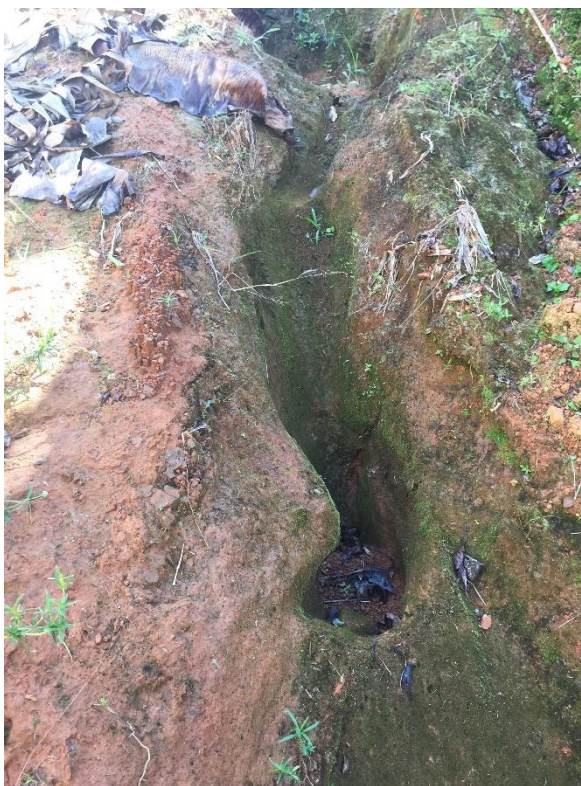
Figure 5. Photos showing the conditions of the dirt roads within San Carlos Farm before BMPs were installed.

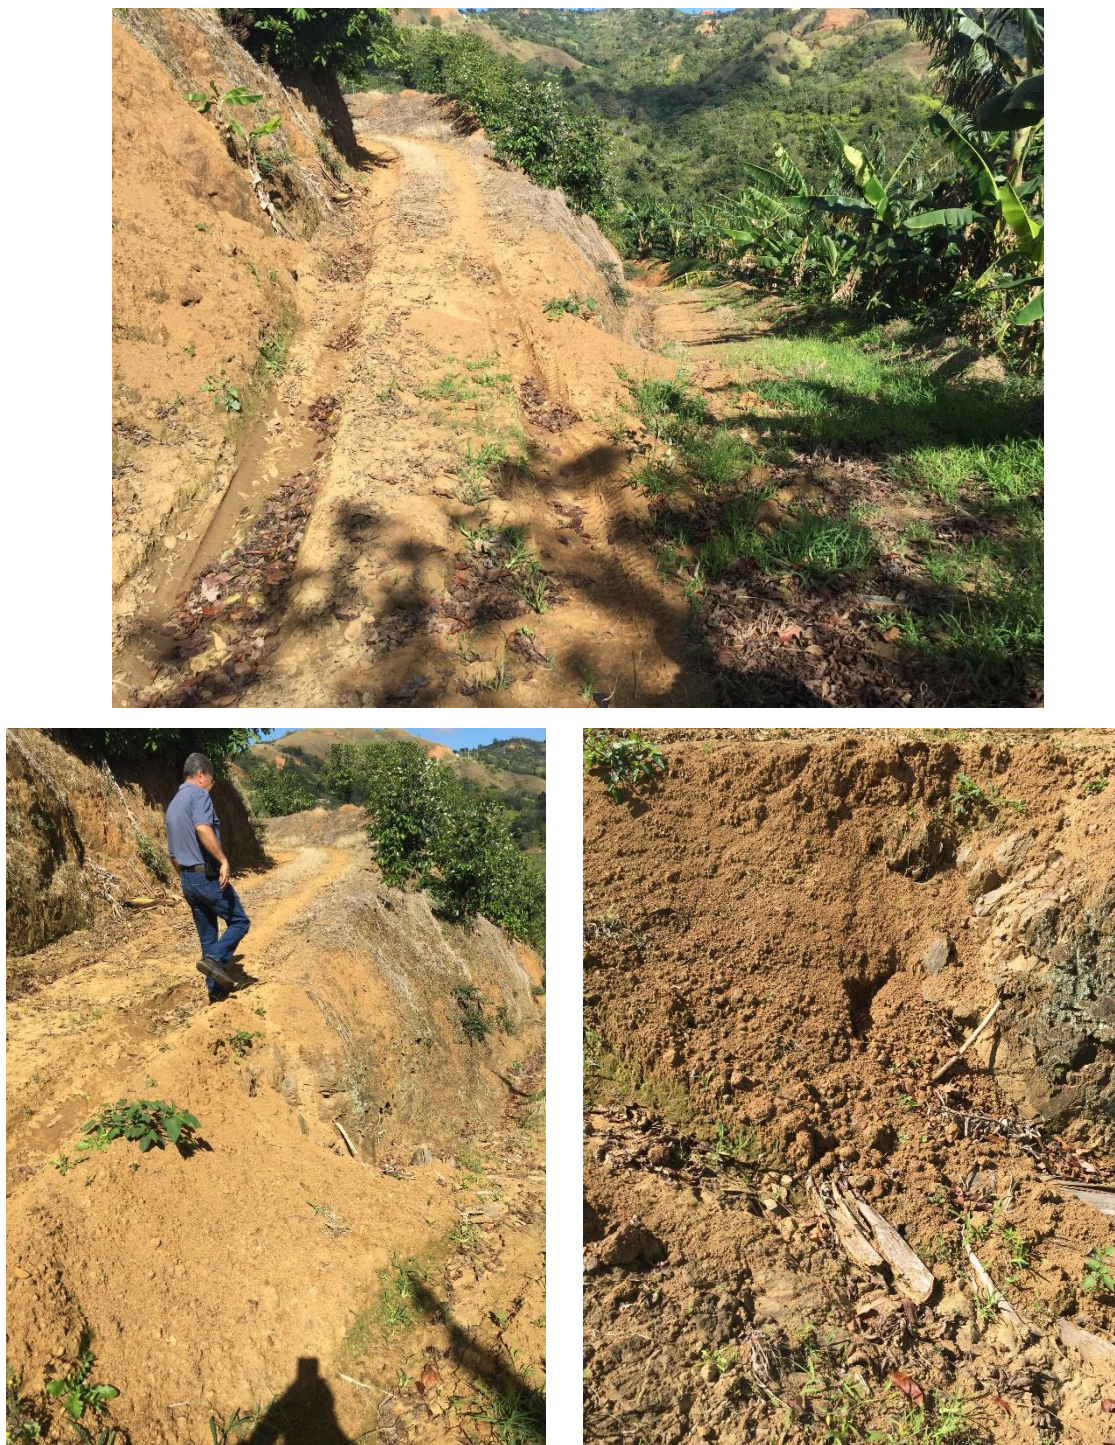
Figure 6. Photos showing the conditions of dirt roads within the Evarista Velez Farm before BMP installation.

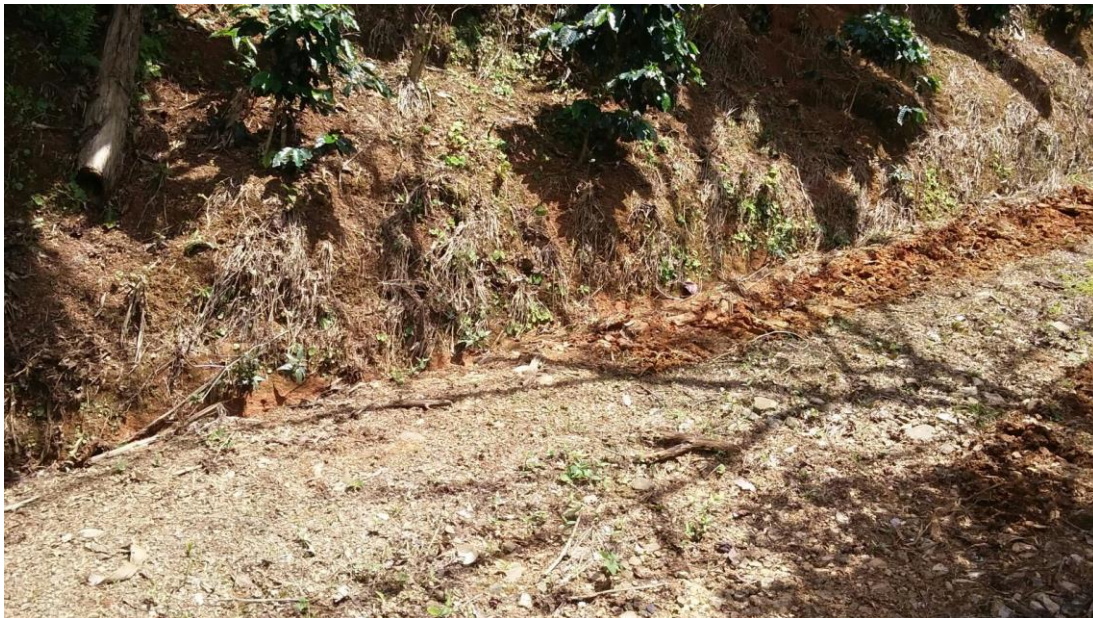
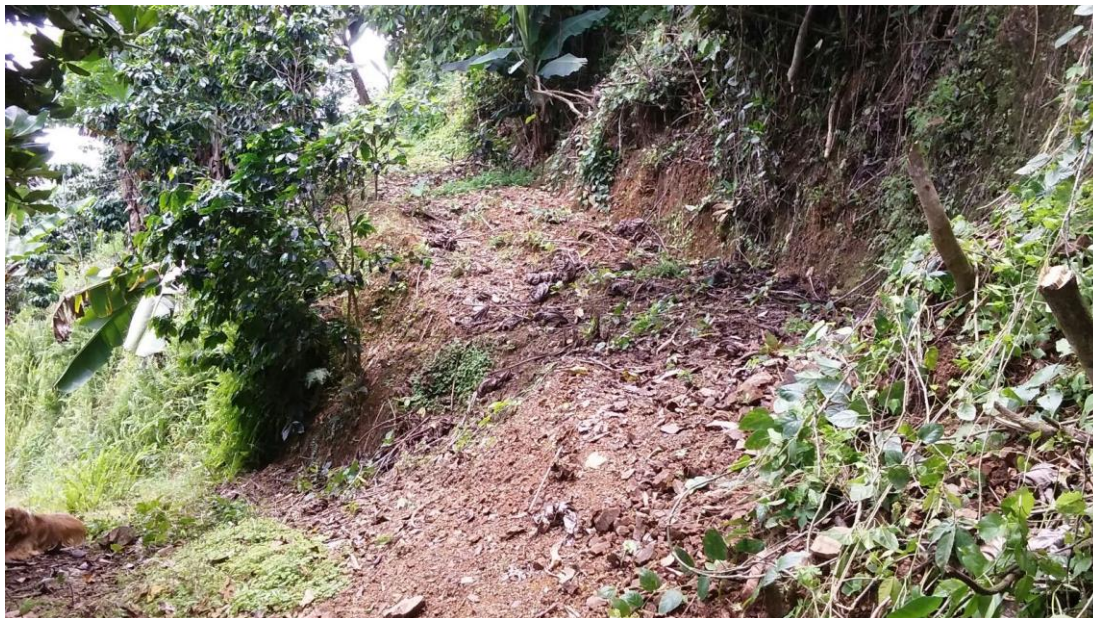
Figure 7. Photos showing the conditions of dirt roads within Hacienda Candelaria before BMP installation.

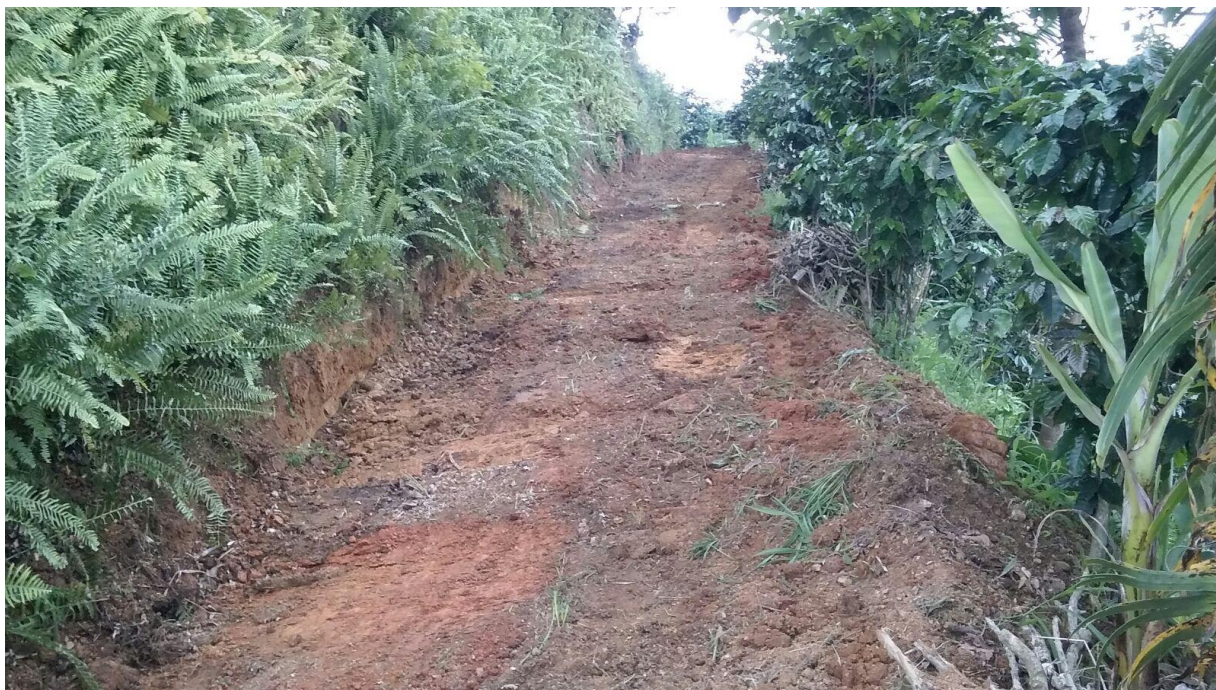
Figure 8. Photo showing the conditions of dirt roads within Hacienda Candelaria before BMP installation.

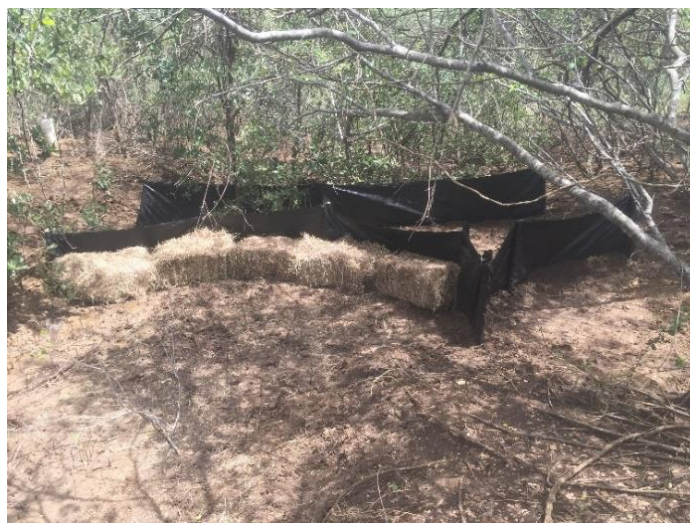
Figure 9. Example of temporary sediment control practices.

Before starting any restoration work in the area, we installed a series of temporary sediment and erosion control practices at the current dirt roads of each farm. Sediment control practices included installing silt fences and planting Vetiver grass to redirect runoff to forested areas (Figure 9).

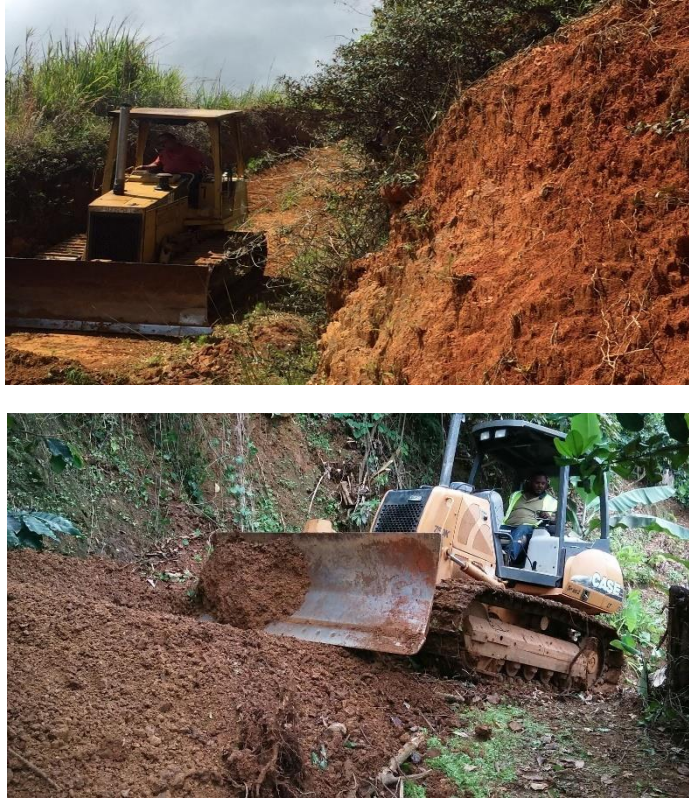
Figure 10. Dirt road regrading process.

Approximately 1.7 miles (using ArcGIS tools) of dirt road was stabilized in all three farms to reduce sediment transport to the GB/RL watershed and eventually the marine environment. All the dirt road stabilized was regraded toward the inside of the hillside and runoff was conveyed into a continuous swale with check dams at intervals of approximately 25-30 ft. depending on the slope. The regrading process was conducted using two bulldozers, one provided by the Yauco Municipality and the other by PDC (Figure 10). Grading activities

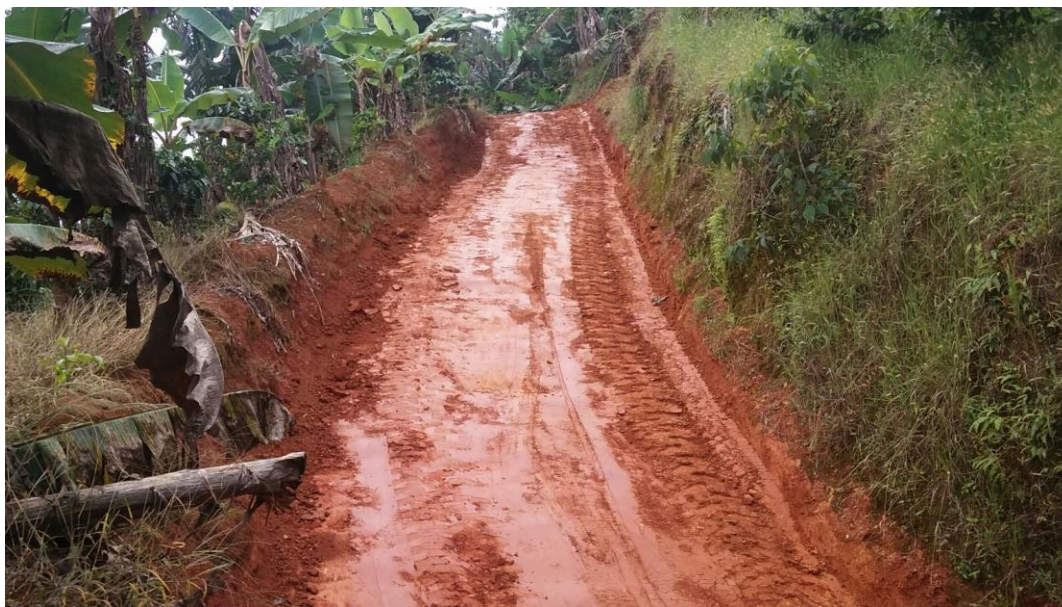
were a bit challenging do to the fact that these roads have been bulldozed so many times in the past decades that the hydrologic conditions desired by the regrading process are very difficult to achieve (Figure 11). Another challenge was that side banks on the roads have vertical slopes and while conducting works part of the slopes falls into the road again. Also, during rain events landslides occur damaging work completed. To overcome these issues in some cases we had to widen roads and a continuous swale was built along the inner side

Figure 11. Dirt road showing problems with high banks.

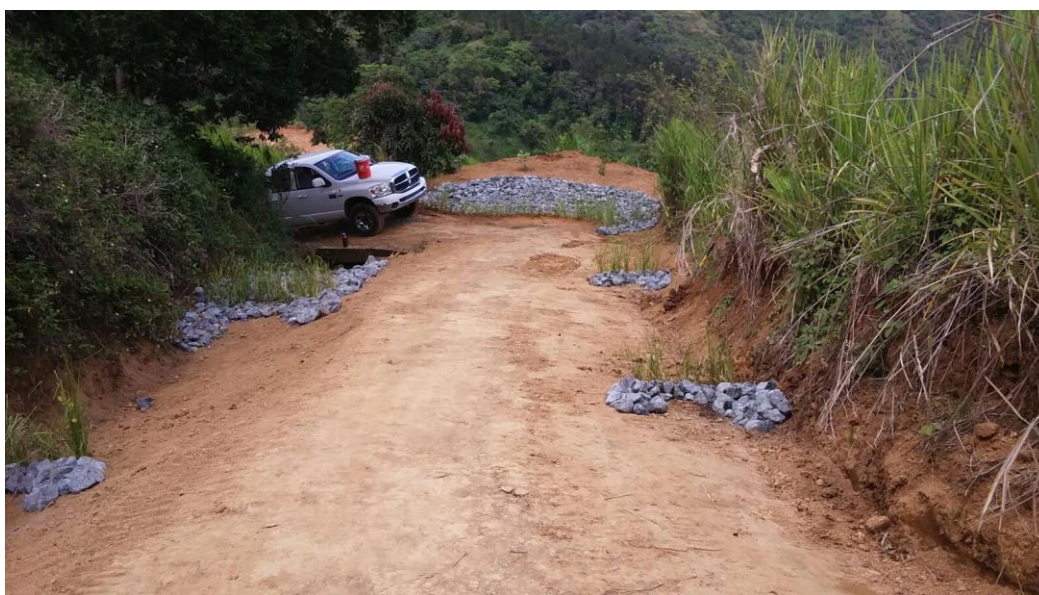
Figure 13. Implemented check dams in combination with a continuous swale.

Check dams are generally used in concentrated flow sites, such as ditches and swales and they can be both a temporary or permanent measurement. They form barriers that prevent erosion and promotes sedimentation by slowing the velocity of water and filtering runoff. Our check dams were implemented in combination with a continuous swale along the inner side of the road. It was almost impossible to cut flow patterns in the swale and get runoff out to forested areas because of the presence of high banks on both sides of the road in many cases and in other instances because of active farmlands that could get affected by the runoff. For this reason, we decided to intersect flow in the continuous swale with the check dams at intervals of approximately 25 to 30 ft. depending on the slope. As stormwater runoff flows through the structure, the check dam catches sediment from the channel itself or from the contributing drainage area. The ones we have built are made from a combination of 8-12 inch stones and Vetiver grass (Figures 13-15).

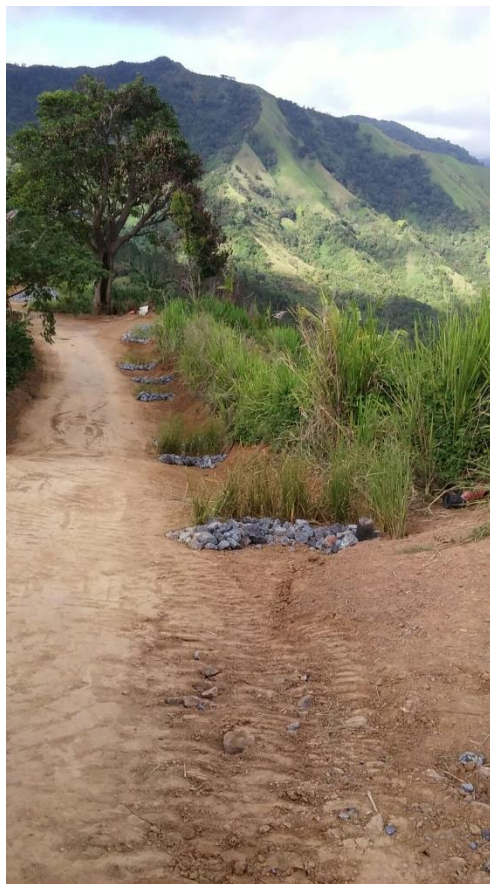
Figure 14. Series of check dams with Vetiver grass constructed.

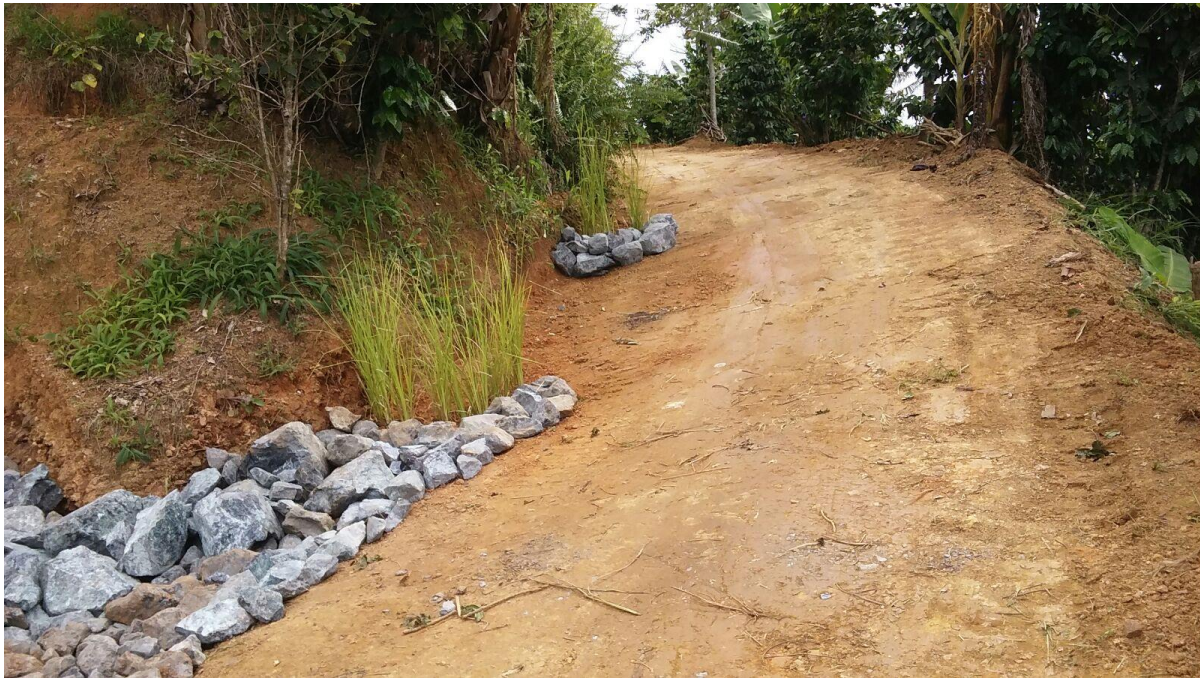
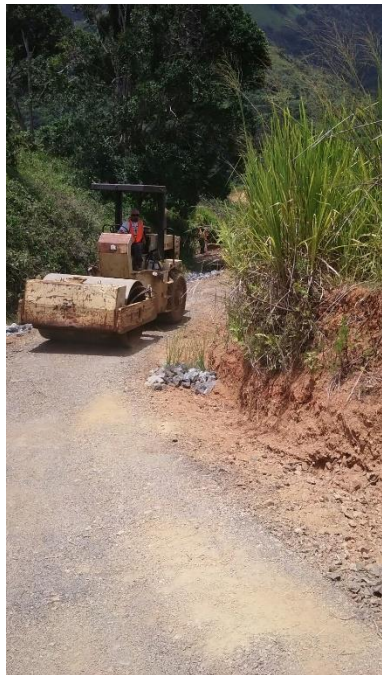
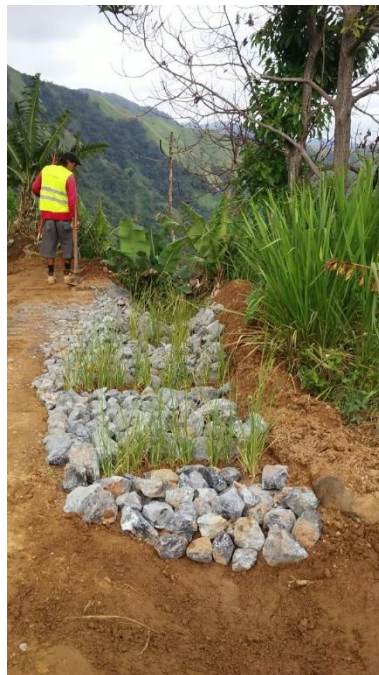
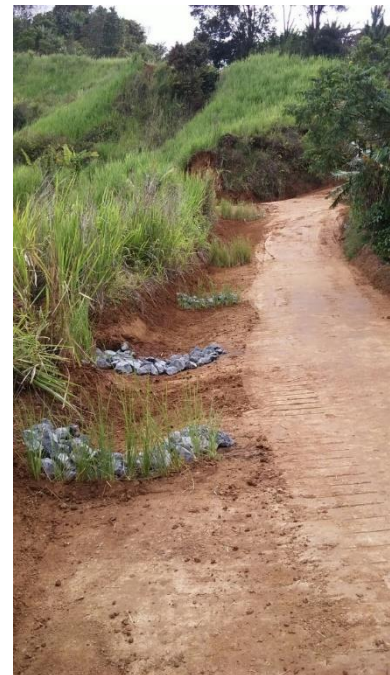
Figure 15. Examples of completed check dams during this project.

Check dams are another cost-effective technique applicable for the selected work site. For the future, we recommend installing erosion control blankets (if the budget is available) because sediment tends to accumulate fast from the dirt intersections between check dams. If stones are not aligned properly and if poorly maintained, check dams will clog and runoff will redirect again to the center of the road causing erosion and damage to the restored section.

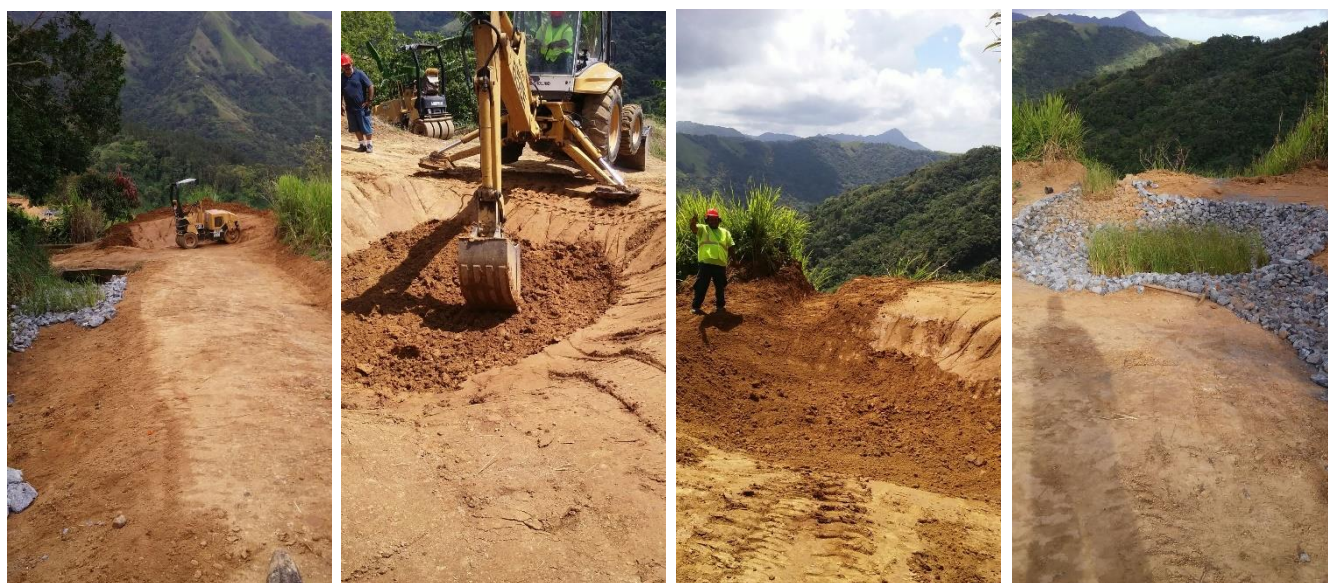
Figure 16. Construction process of sediment traps at San Carlos and Evarista Velez Farms.

Sediment trapping techniques have demonstrated that work better when constructed with functional redundancy. According to Mekkonen (2015), integrated sediment trapping is the most effective approach to manage sediment migration when compared with individual and combined measures alone. A series of sediment traps were constructed to help filter storm water that was causing erosion problems and discharging sediments (Figures 16-17). The traps were formed by excavating an area across a low portion of drainage swale and berms were constructed and compacted with the small compacting roll. After compacting, the sediment traps where covered with 2-8 inch stones as rip-rap to prevent erosion from the berms and the bottom was punched through with the backhoe to promote infiltration and vetiver half-moons were planted to help trap sediment and promote infiltration and evapotranspiration. A rip-rap overflow was constructed with bigger 1-2 ft. stones to reduce energy of the water. The San Carlos and Evarista Velez Farms

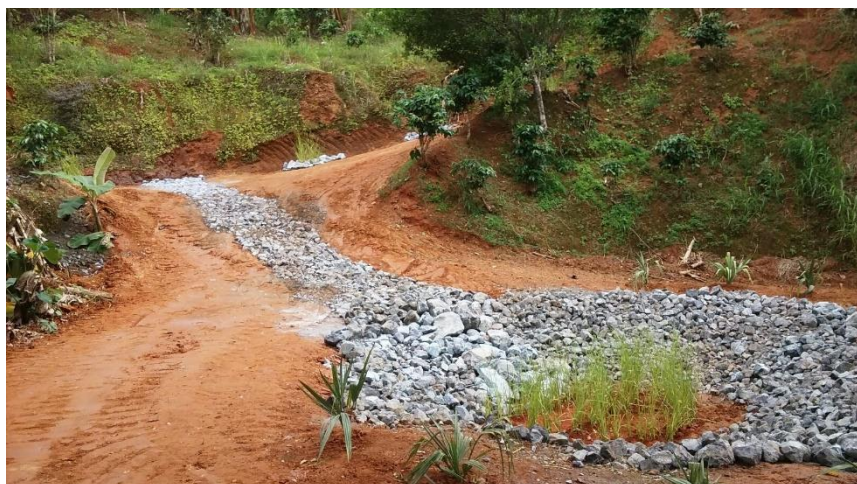
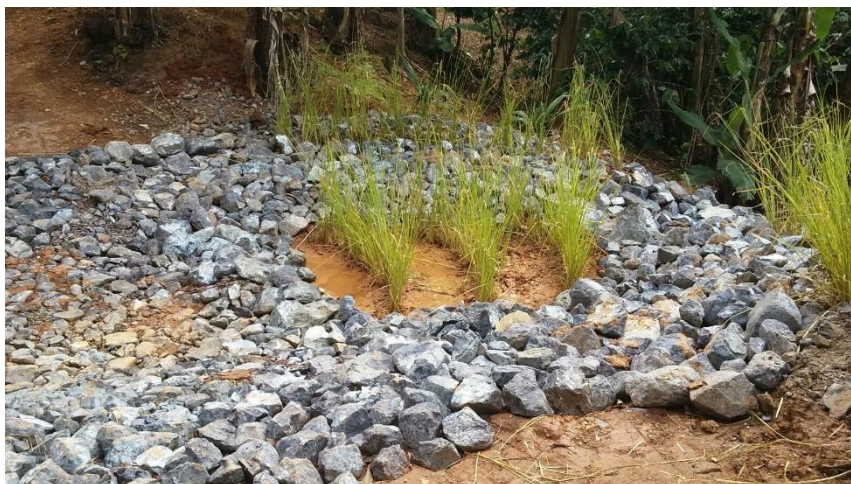
Figure 17. Sediment traps at San Carlos and Evarista Velez Farms.

are neighboring farms and were worked as a single unit to maximize results and benefits to the watershed. A total of 3 sediment traps were created between these two farms near drainage points. On the other hand, sediment traps were not created at Hacienda Candelaria as this farm already had a space that could serve as a sediment basin so we created a bigger basin that covers most of the drainage area that was stabilized (Figure 18-19). The size of the sediment traps constructed depended on the available space and slopes.

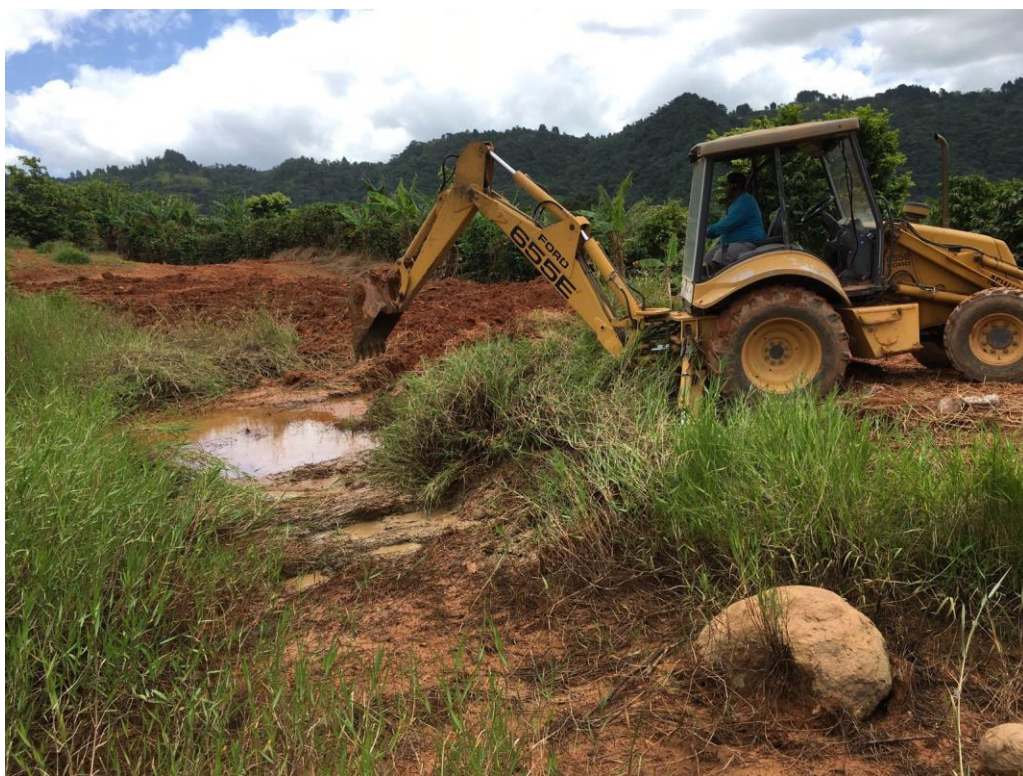
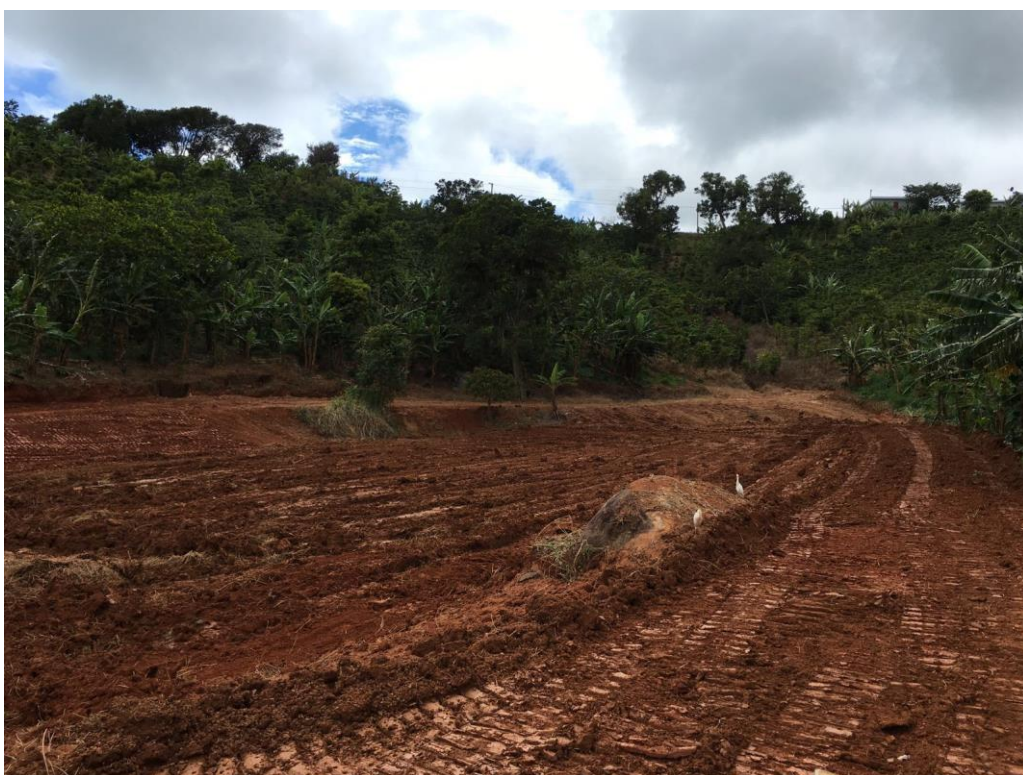
Figure 18. Construction process of sediment basin at Hacienda Candelaria.

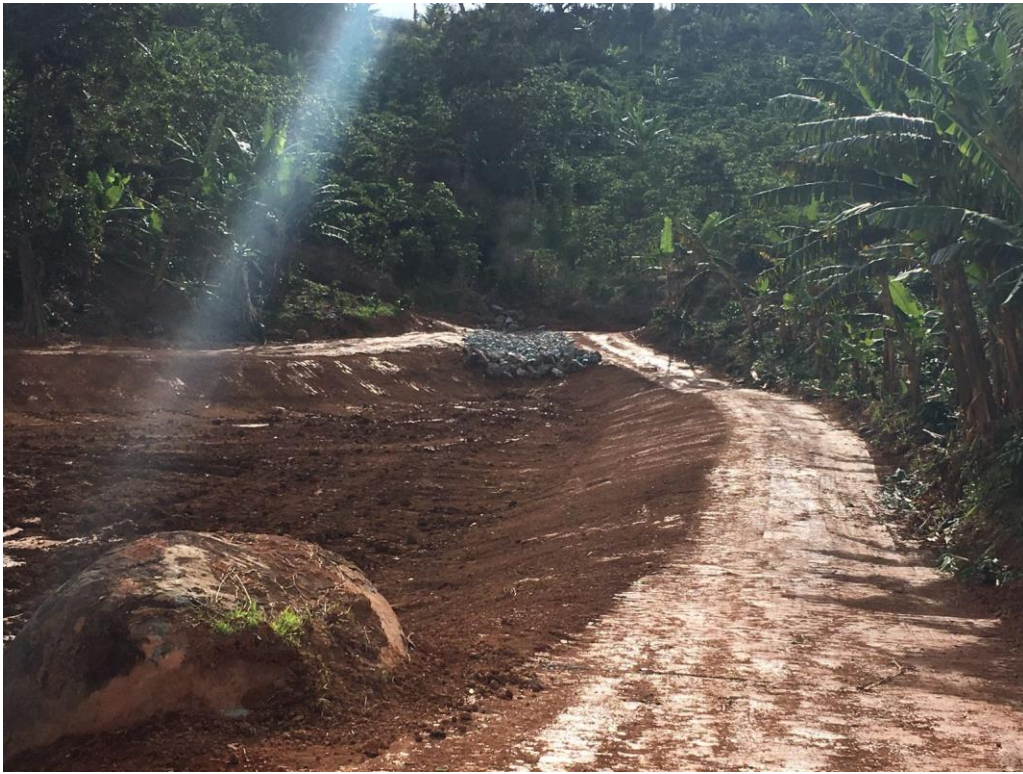
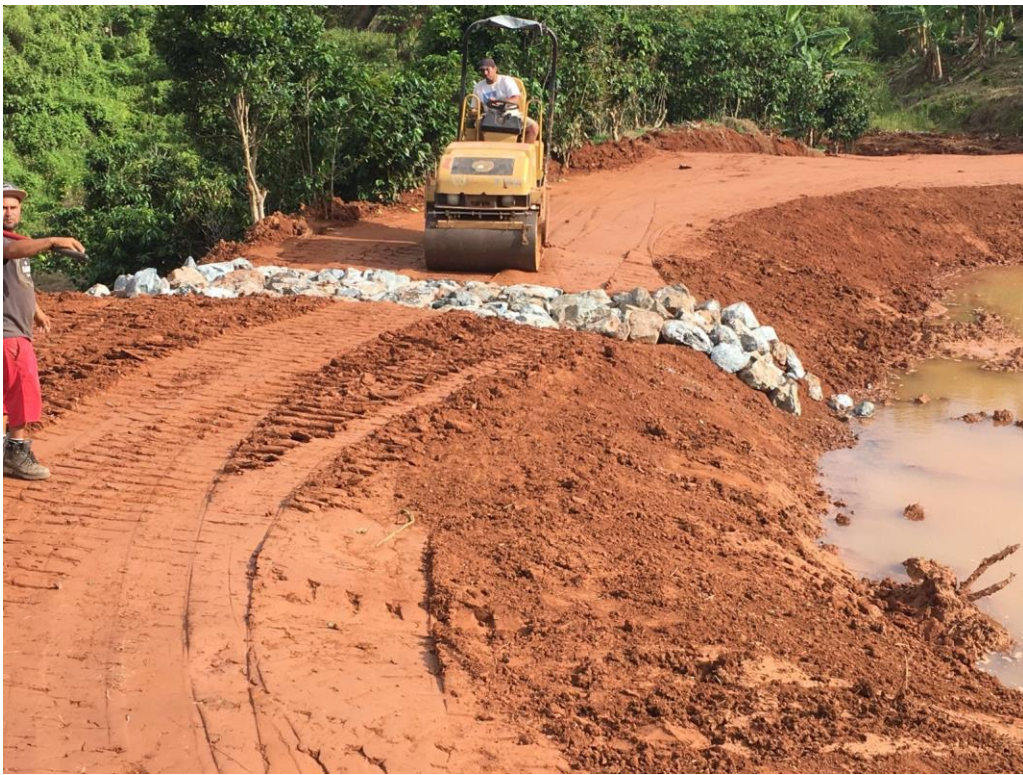
Figure 19. Construction process of sediment basin at Hacienda Candelaria.

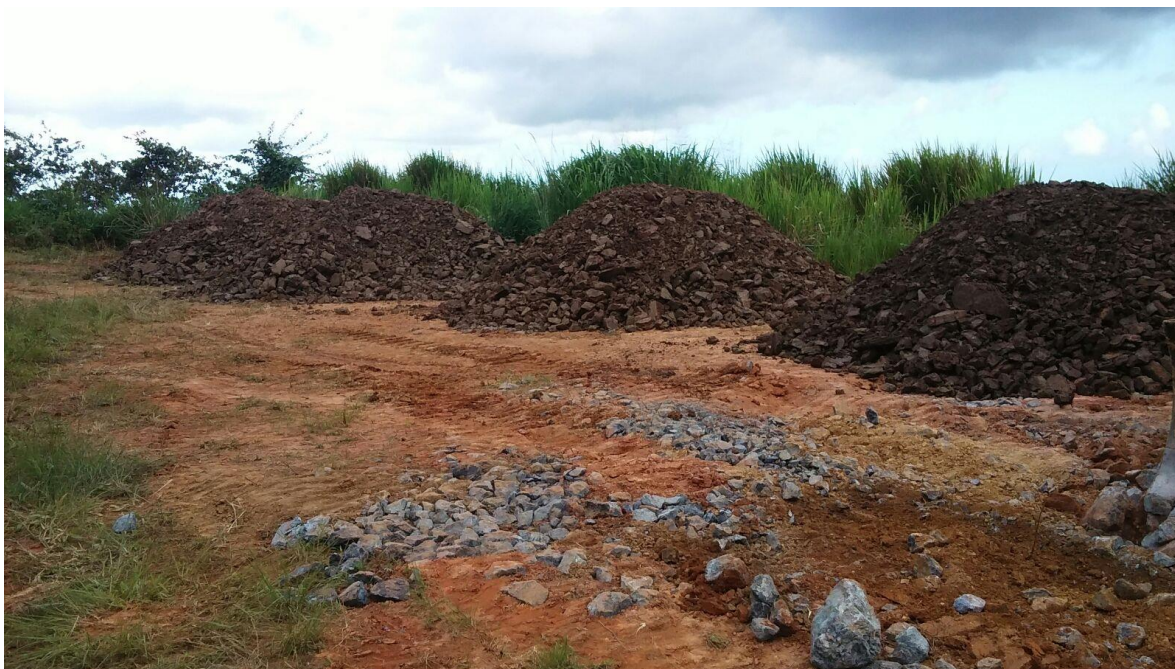
Figure 20. Fill granulated material piled on the side of the road prior to be applied.

Dirt road stabilization techniques included using fill material to stabilize the steep segments of the roads. Modifications of the stabilization techniques were necessary during the process as the soil of the dirt roads are of very high clay content. The fill material layer used for road stabilization contained small rocks and granulate materials that makes it a good soil mixture for compaction (Figure 20). The road was compacted using a small compacting roller offered in-kind by the Municipality of Yauco (Figures 21). Since this practice was not contemplated when we wrote the proposal the farmers provided the fill material as an in-kind contribution to prevent budgetary increases of the project.

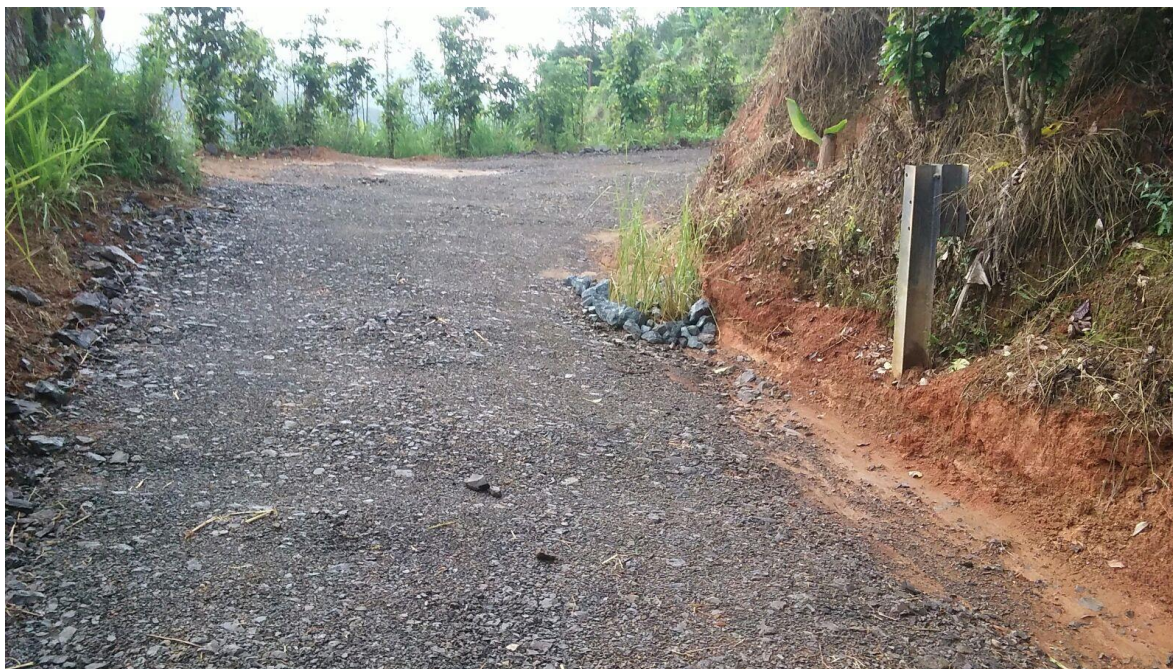
Figure 21. Dirt road after completed paving and compaction.

The use of this paving material was one of the most effective practice implemented and it was demonstrated by the research component done in collaboration with Dr. Carlos Ramos from the University of Texas at Austin (a more detailed description can be found at

the end of this report). In the future, we recommend using this technique in all of the dirt road network when the budget is available as it is a cost-effective way of preventing road deterioration by rainfall and subsequent runoff and erosion problems.

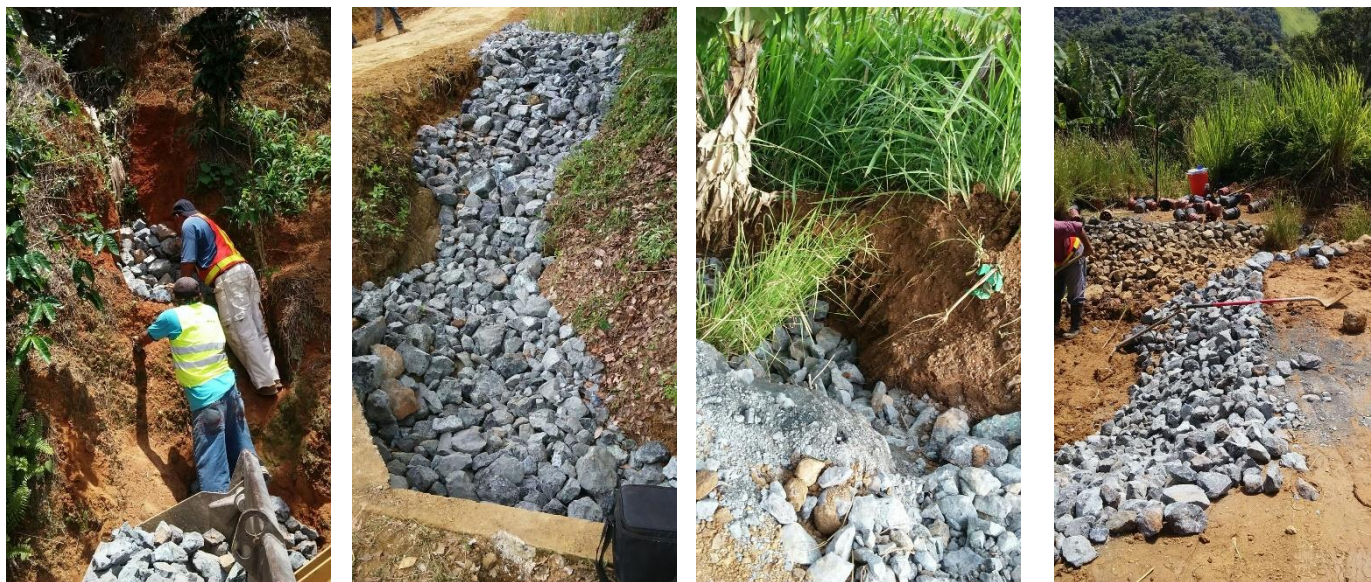
Figure 22. Construction process of rip-rap.

Rip-Rap consists of a permanent sediment and erosion control practice made with resistant ground cover and the use of large angular stones. It is commonly used to protect slopes, streambanks, channels, or areas subjected to erosion by wave action. Rock rip-rap protects soil from erosion due to concentrated runoff. It is used to stabilize slopes that are unstable due to seepage. It is also used to slow the velocity of concentrated runoff which in turn increases the potential for infiltration. In our case, rip-rap was used to protect sediment trap constructed berms and in overflows. In the sediment traps, rip-rap provided some water quality benefits by increasing roughness and decreasing the velocity of the flow, resulting in better settling of particulates. In other areas, we used rip-rap in existing water ways and it offered an easy-to-use method for decreasing water velocity and protecting slopes from erosion. It is simple to install and maintain (Figures 22-24).

In some cases, we used them for the inlet of the sediment traps and in the sediment basin to reduce the energy of the runoff entering the traps. This practice demonstrated to be an effective technique in the berms and the outflows. In the inlets, they did a great job for the first rain event but it tends to clog rapidly and needs more maintenance so we don't recommend it for the inlet of the constructed traps.

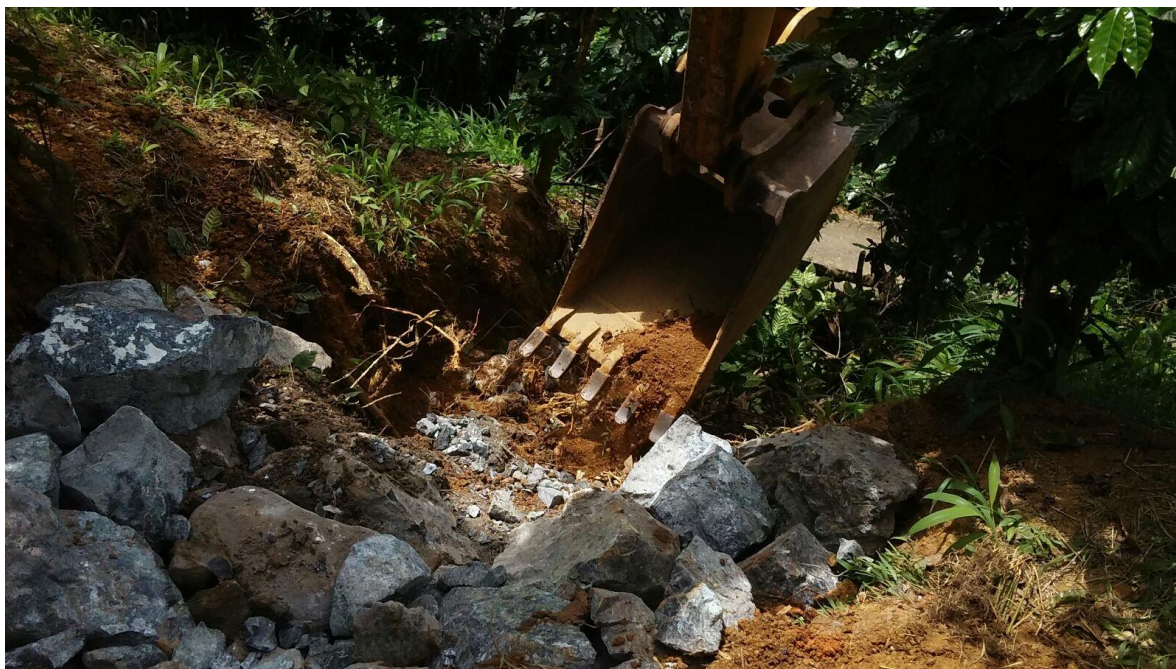
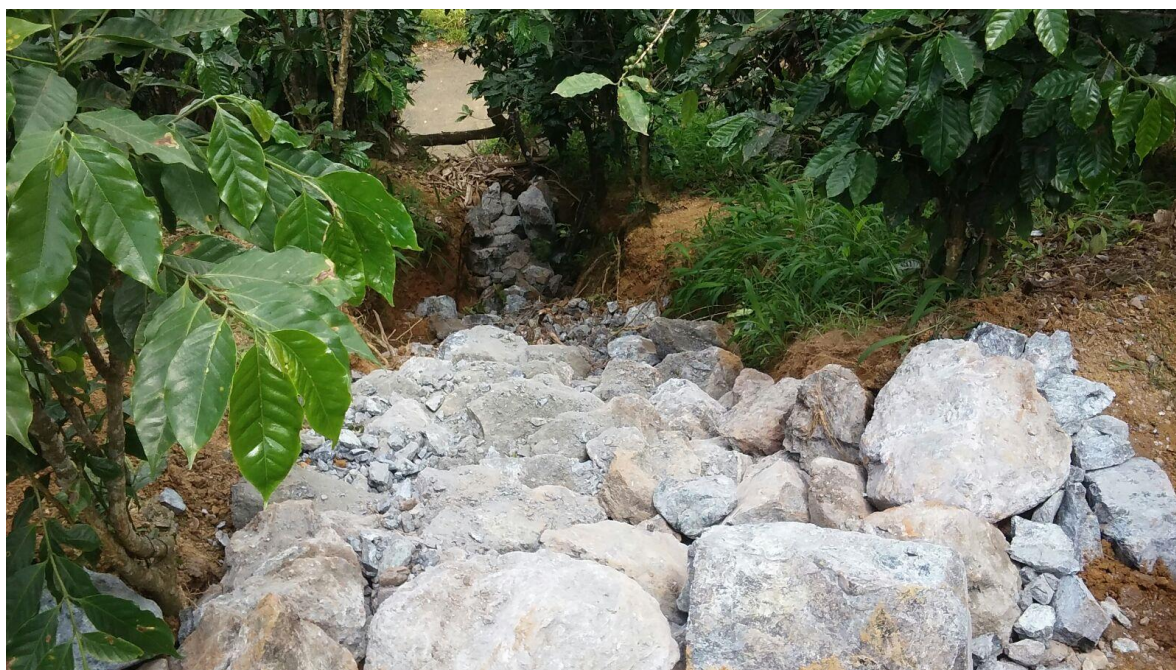
Figure 23. Construction process of rip-rap.

For this practice, we recommend that stones are of good quality, correctly sized, and placed to proper thickness. A filter fabric should be used to cover the soil prior to the installation of the proper size stones. In our case, we did not use it based on budgetary
